SOJ-6(22)

‘Screws’, or tricks of trade: secret repairs of solid cast cannon by Jan Verbruggen

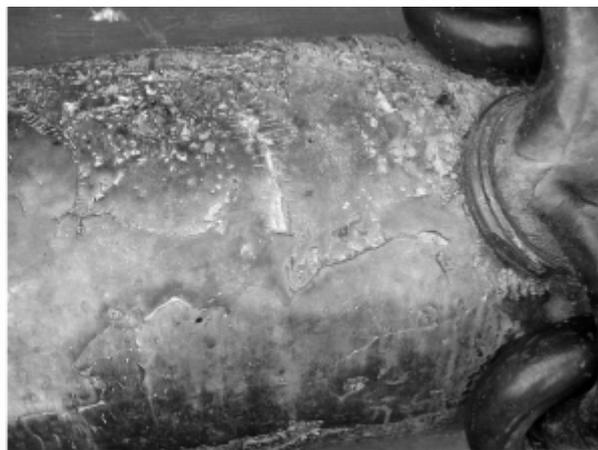
It was difficult to cast a good quality bronze gun and gun founders who were confronted with impurities preferred to repair those guns rather than recast them.

In the 17th century an unnamed Javanese gunfounder cast the ‘Kjai Pantjavoera’ and then made these extensive repairs, showing a wide variety of techniques, undoubtedly also known by Jan Verbruggen, like the dented patches, seen on the photo on the left. Incredibly the gun was actually fired in anger against the Dutch. Today the gun is displayed near the Sultan’s Palace, Surakarta, Indonesia.

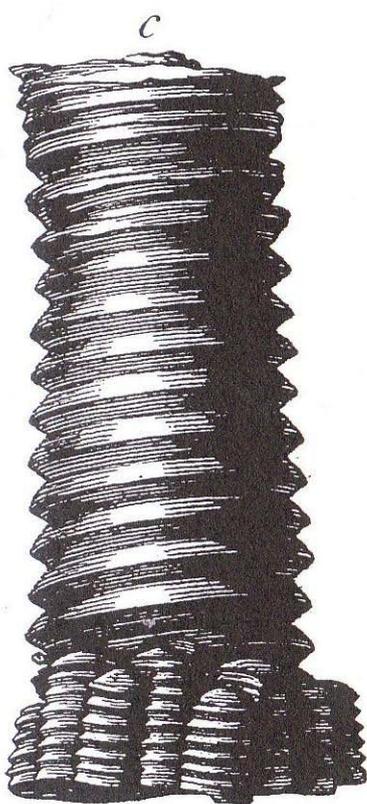
Verbruggens screws, patches and stops, as retrieved from the secretly repaired guns.

These are drawings of the remains of the screws used by Verbruggen with the screw-heads were cut off during the repairing process. The screws "c" and "d" show the complex compound of a large screw with several small screws added. These drawings formed part of the official report against Jan Verbruggen.
