The Napoleon Series

River Crossings in the Peninsular War: the Bridge at Alcantara

By [Richard Tennant](#)

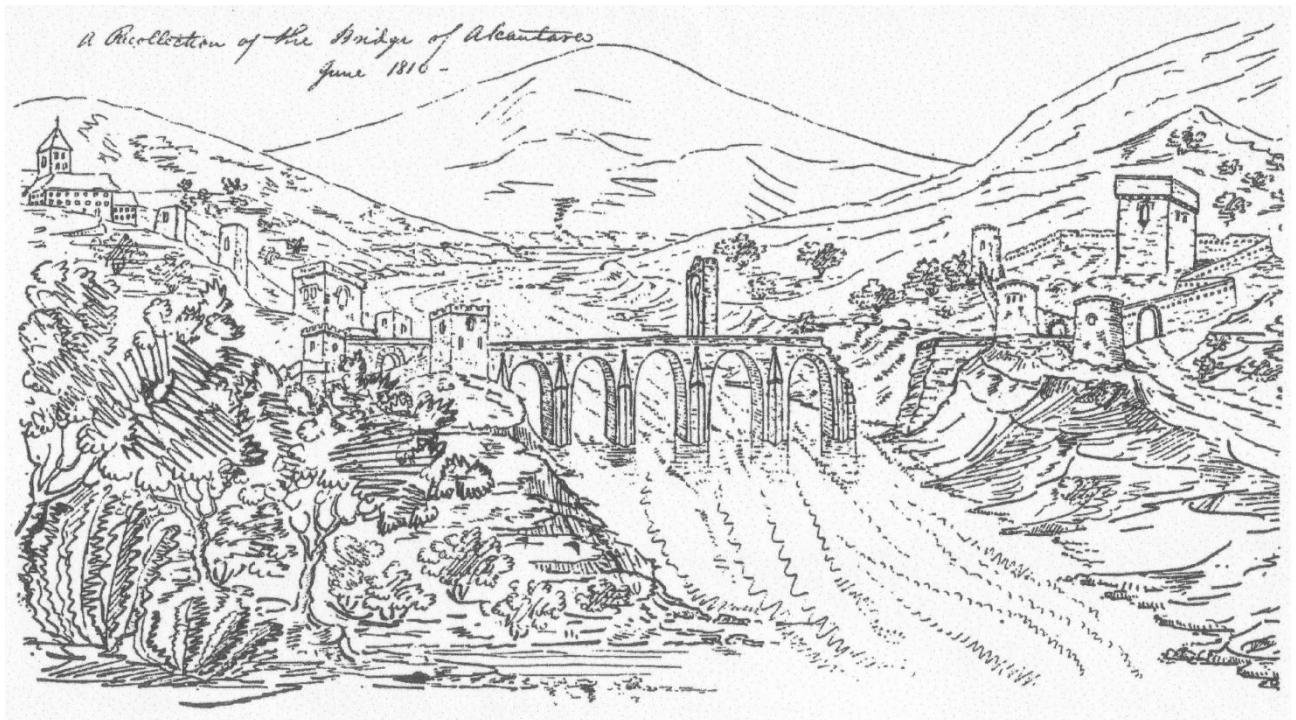
[The sketch is reduced from the original drawing made by Dickson. It was most probably elaborated at a later date, from the small sketch and description in the diary. The sketch is taken looking down stream, the town of Alcantara being situated on the left bank.]

30 feet broad, entirely built of large square stones. There are six arches, 5 of which are perfect, and the 6th, being the one on the opposite extremity from Alcantara was broken down last year about May, by order of Colonel Mayne of the Loyal Lusitanian Legion on the approach of the enemy."

Although only one arch is broke down and that not the largest, it makes a gap I should think very nearly two hundred feet wide, and from the great height, it would be very difficult if not impossible to repair it with wood, or in any other temporary manner. To understand the reason of the gap being of so great a breadth, see the Mem. (*memorandum / drawing*)."

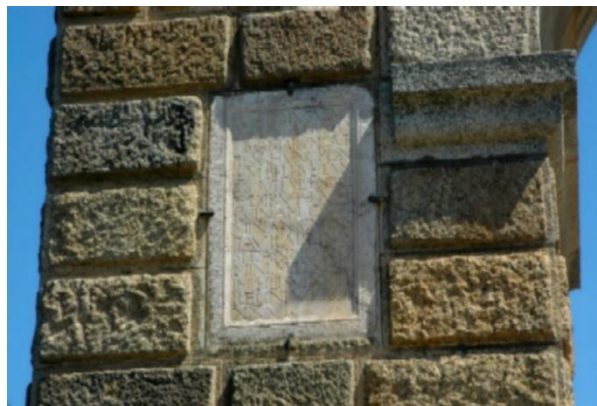
Detail of the left of the archway

The arches are very high, but not broad in proportion, being what are called upright, but they are nevertheless very broad, particularly the two centre ones. In the center of the bridge there is a triumphal arch which has on each side of it the inscription: (*translation of the Roman text*) *To the Caesar, son of the divine Nerva, Nerva Trajanus Augustus, Germanicus, Dacicus, Supreme Pontiff, in the 8th year of his Tribunical power, when Imperator for the 6th time, consul for the 5th time, Father of his Country*⁴."

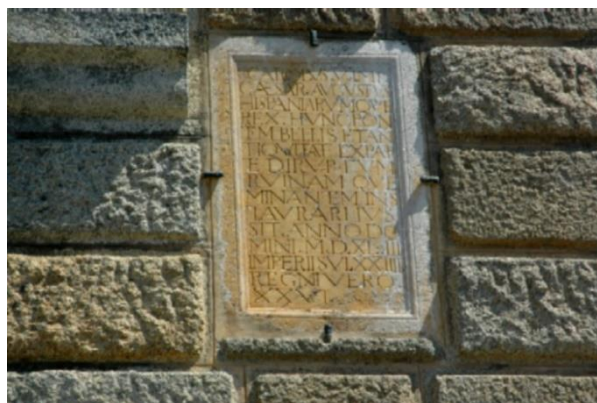
Detail of the right of the archway

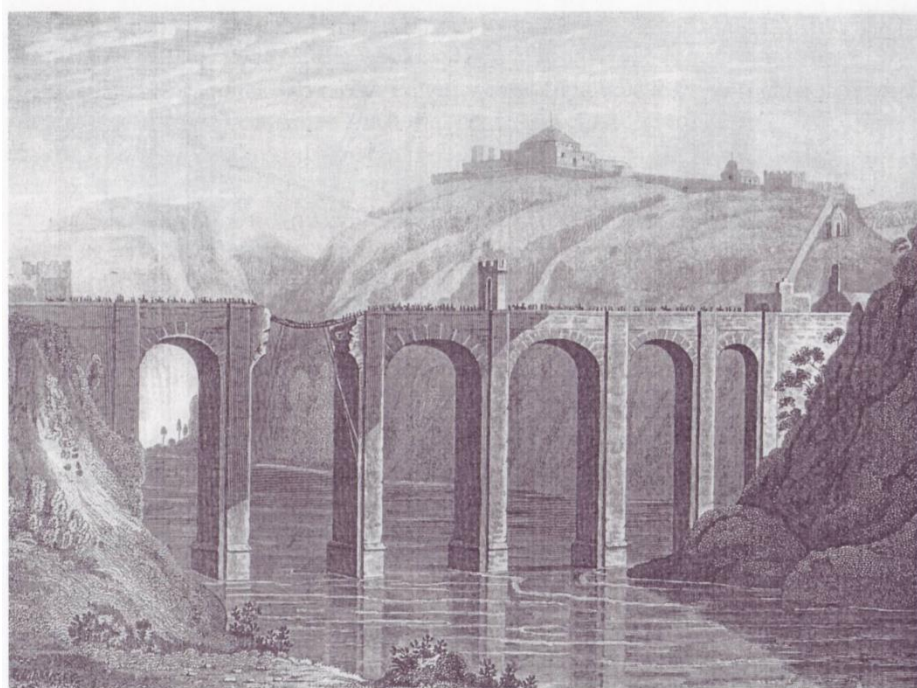
A Contemporary View of the Bridge at Alcántara as Seen from the Left Bank. By Major General Howard Douglas

[In Sir Howard Douglas' *Military Bridges*, 3rd edition, 1853, there is a picture of this bridge showing the broken arch as that *next but one* to the north bank. Baedeker's *Spain and Portugal*, 1901 gives it as *the 2nd arch from the north bank*, as does O'Shea's *Guide to Spain and Portugal*, 6th edition, 1879. Douglas says that it was destroyed in 1809 *by the French* which is certainly incorrect.]

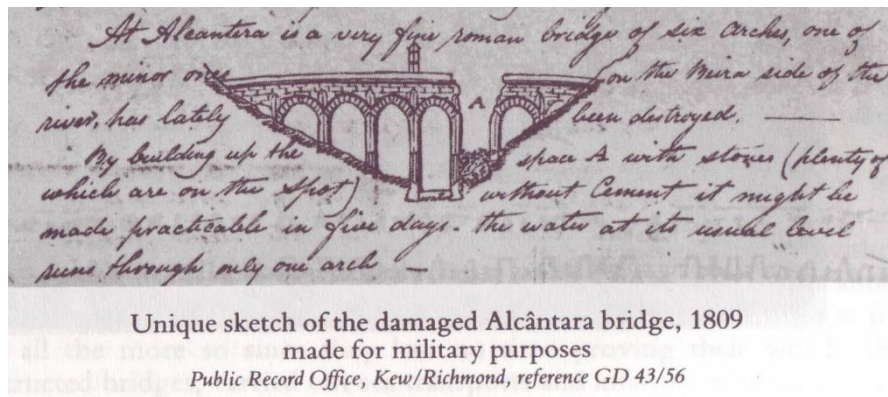
At Alcântara is a very fine roman bridge of six arches, one of minor ones on the Beira side of the river has lately been destroyed. By building up the space A with stones (plenty of which are on the spot) without cement, it might be made practicable in five days. The water at its usual level runs through only one arch.

Note: compare the water level in this sketch with it as shown when sketched by Dickson in the month of June. His editor, Major JH Leslie, notes that 'the usual depth of the water is 37 feet, but in time of flood it sometimes rises in the narrow gorge to a height of 180 feet.'

(Also, the sketch illustrated⁵, taken from a manuscript in the PRO, shows this particular arch as being destroyed. Again, there is a sketch in the *Royal Engineers Journal*, attributed to Major Sturgeon, clearly showing it to be the second arch from the north bank.)

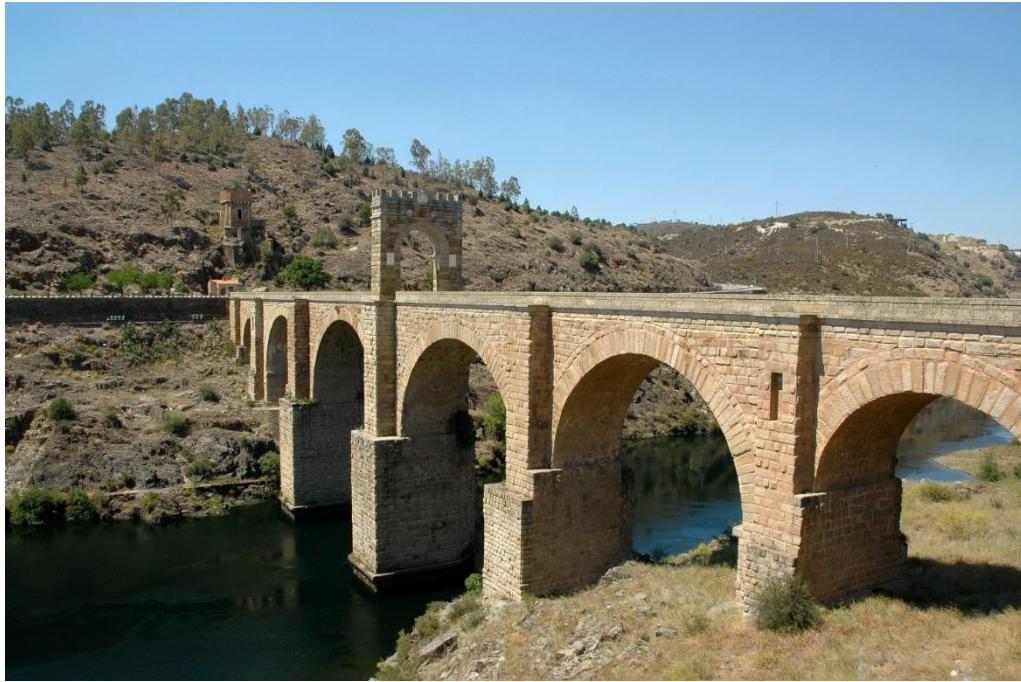
The bridge viewed from the south bank, looking north

The bridge is made wholly of granite without the use of mortar. Its length is 616 feet; its width 26 feet. The two middle piers are about 190 feet high, and the two middle arches have a span of 150 feet. The usual depth of the water is 37 feet, but in time of flood it sometimes rises in the narrow gorge to a height of 180 feet.

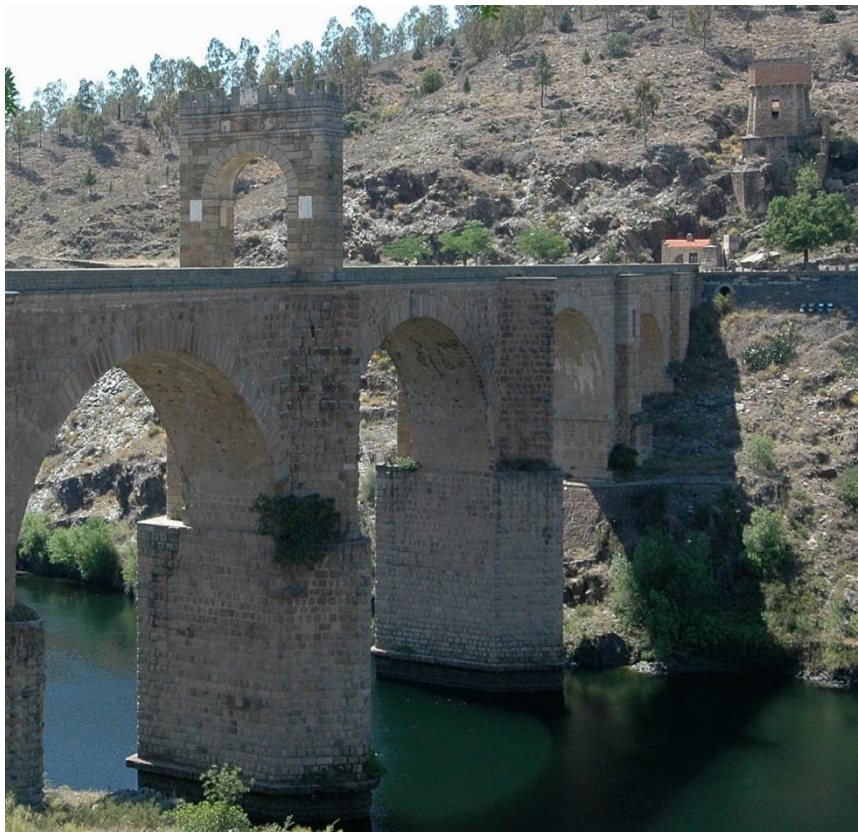
This view from the south bank appears to show the repaired arches

The entire bridge was thoroughly restored in 1860 by the architect Alejandro Millan.
Ed. *Major JH Leslie*]

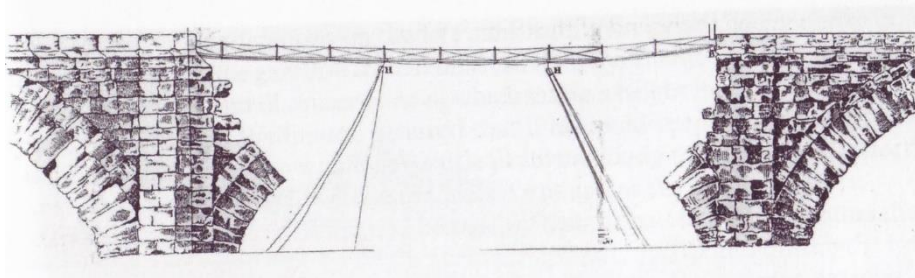
A screen of tarpaulins supported by guide ropes acted as parapets to block the vision of the horses and oxen, and thus prevent a possible panic. Even so, a couple of diaries reported that many animals (and even a regimental paymaster) took fright at the swaying and the height. Hand-operated windlass/ capstans were also necessary to adjust the cables for changes in length due to moisture and to better support heavy vehicles.

The whole thing could be taken up or set in place within a few hours if the enemy appeared in the neighbourhood, which was necessary several times.

The work was commenced by placing two beams on supporters four feet high and ninety feet asunder. These were secured to the side and end walls of the building by braces and tackles, to prevent their approximating by the straining of the ropes. Eighteen cables were then stretched round them, extending from end to end; eight pieces of timber, six inches square, at equal distances, were placed upon the ropes, with notches, one foot asunder, cut in their surface to secure them; these notches were seared with hot irons to prevent the ropes from chaffing. The cables were then lashed to the beams; they were netted together by rope-yarn, and chains of sleepers were bolted and laid on the network, and secured to the two beams originally placed at the extremities of the work. Planks were cut and prepared for being laid across, bored at the ends so as to receive a line destined to secure them to the sleepers and to each other. ... The next point was to prepare the edge of the fractured part of the bridge, and to cut channels in the masonry for the reception of the purchases. When arrived on the spot, four strong ropes were stretched from side to side, as conductors, for passing the cable-bridge across, the beam on the south side having been previously sunk into the masonry; the whole was then stretched by windlass erected on the opposite pier, by which means it was so tightly drawn as to prevent any great sinking or vibration which might render it insecure and dangerous, even when heavy weights were passed over."

A detailed account of the method and materials of the repair is given in Douglas' *Military Bridges*, pp 353 – 359 (including the illustration above), referred to earlier by Major Leslie.⁹
